On July 31, 2019 our well located on Road 27 and Avenue 18 ½ was taken out of service.

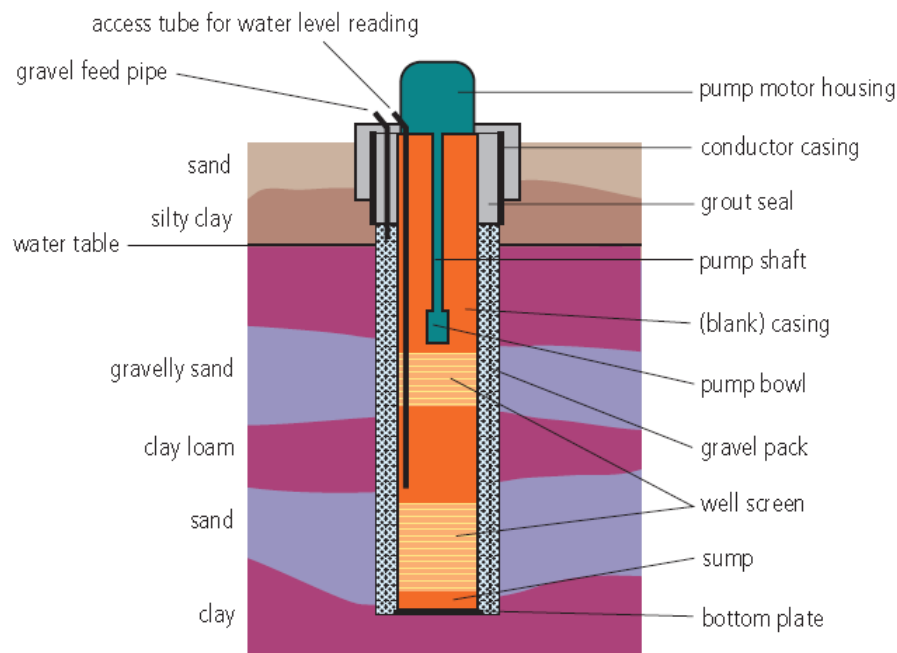
Figure 1. Components of a well.

All evidence indicates that the well casing has sustained damage. (See Figure 1 below) This is not due to age, or wear of the well casing. The most likely cause is the recent earthquakes we have experienced and/or ground subsidence due to the overdraft of the ground water table.

We will not know the full extent of the damage until the pump has been removed from the well and the casing has been examined with a submersible camera.

Without knowing the full extent of the damage the best estimate we can give at this time is that this well will be out of service for a minimum of 2 weeks for evaluation and repair.
